**CENTAUR TANK CORROSION  
TESTS AND X-RAYS**

**Report Number GD/C-BNZ65-032  
1 August 1965**

**Contract Number NAS3-3232**

This report documents procedures for monitoring, controlling, and preventing spotweld corrosion on present, as well as future, Centaur tank structures.

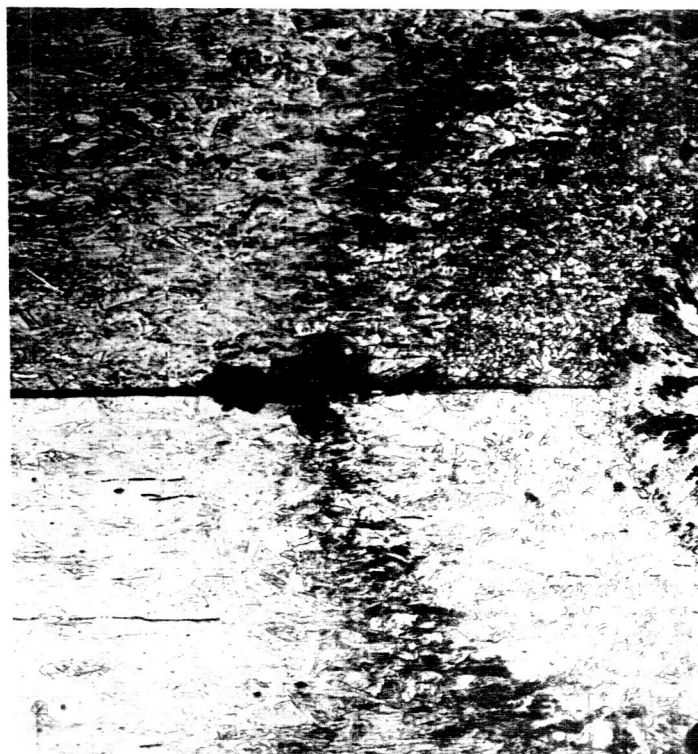
Figure 1-1. Spotweld Cross-Section Showing Corrosion Pit

PHOTOMICROGRAPH OF THE CROSS-SECTIONED SPOTWELD  
(MAG. 25X; ELECTROLYTIC OXALIC ACID ETCH).

PHOTOMICROGRAPH AT A HIGHER MAGNIFICATION (100X) OF THE LEFT SIDE  
OF THE SPOTWELD SHOWN ABOVE (ELECTROLYTIC OXALIC ACID ETCH).

1.1.3 BACKGROUND INFORMATION. Radiographic inspection is routinely employed to verify the quality of each spotweld during subassembly fabrication and during Centaur final tank assembly operations. X-rays verified that upon completion of each major subassembly operation all spotwelds were free from corrosion defects. Subsequently, the subassemblies were stored until final tank assembly. Following the cryogenic pressure proof test, the tank was subjected to a post-cryo radiographic inspection. Analyzing post-cryo X-rays of 2D (AC-6) and 3D (AC-7) indicated spotweld cracks and pits were developing. Re-X-rays confirmed that the pits and cracks had increased in both quantity and size. Samples of the affected spotwelds are shown in Figures 1-1 and 1-2.

2.1.4 FORMATION. The conditions described in paragraph 2.1.3 result in pits and cracks as shown in Figure 1-1 and 1-2. These branching cracks have been found to be both intergranular and transgranular and are similar in appearance to cracks produced by stress corrosion. They appear to originate as a pit and form cracks due to stresses set up during metal cooling, or could originate as micro-cracks, produced during welding operation, which were attacked and opened up by a corrosive fluid in the faying surface. This fluid may be one of the corrosive processing fluids listed in Table 3-3 which may have become trapped between the faying surfaces before or after the sheets were spotwelded. Corrosion may also have been initiated by non-corrosive solutions combining with salt or other dry corrosive elements, which settled from the atmosphere during tank buildup, forming electrolytes or corrosive solutions.
